Service Bulletin #3

May 11, 1977

CP300/400 SERVICE NOTES

Noise Blanker Modification (CP-300/CP-400):

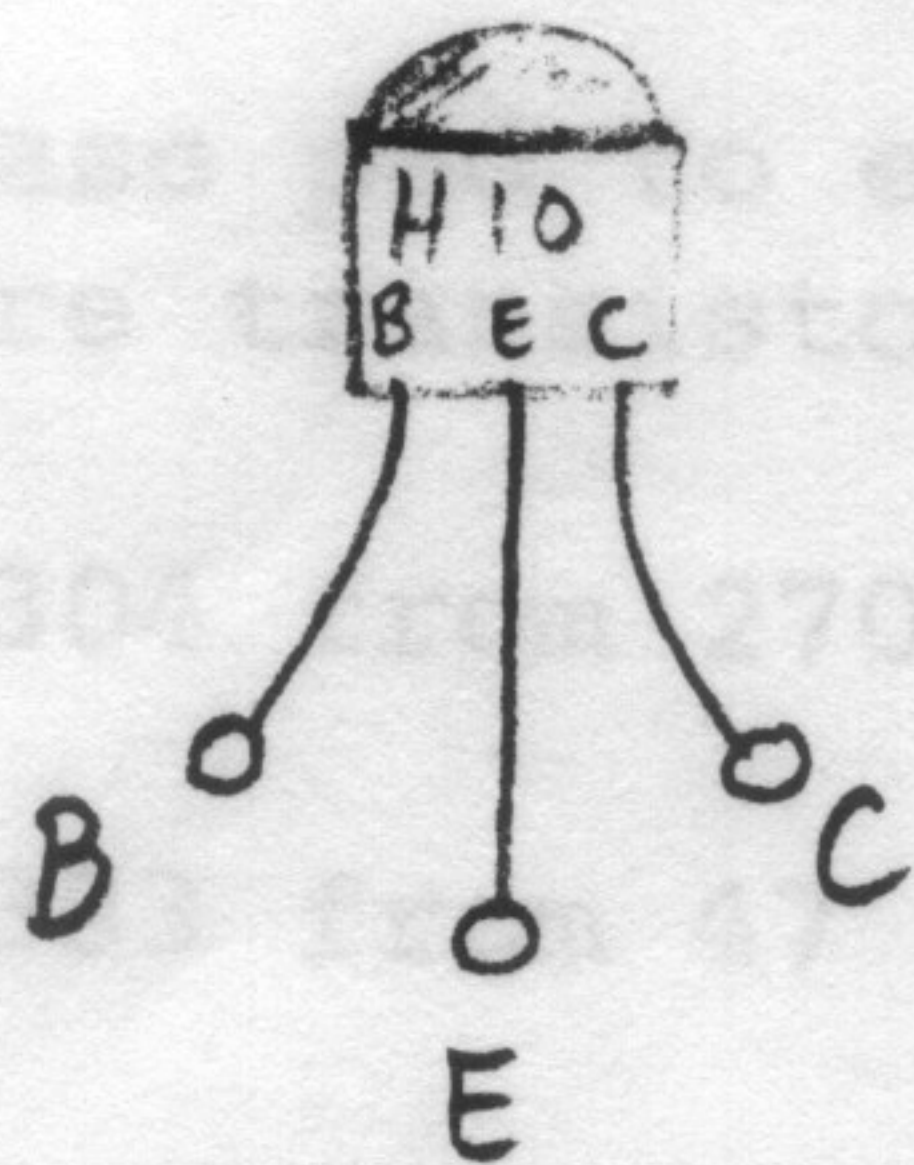
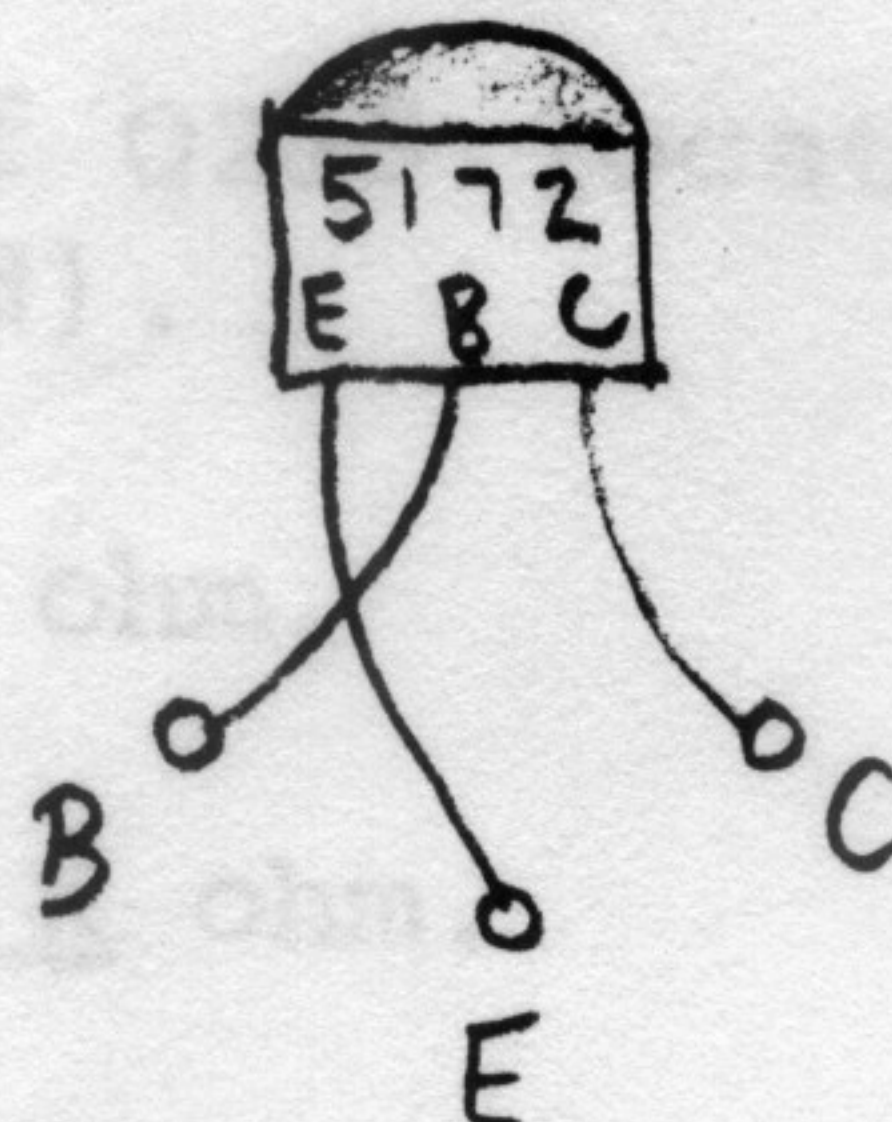
The following Modification is designed to improve the sensitivity and performance of the noise blanker. It is incorporated in all CP-400 shipped after May 1, 1977.

1. Locate four shield cans comprising front end of receiver (directly behind crystal filter). Remove two cans towards front of radio, L211 and L214 on layout in manual.
2. Replace Q224 on RT Board with MPS 5172. Note that the emitter and base are reversed as compared to the H10. See drawing.

3. Replace C297, 5pf disc with 2 pf disc. This capacitor is next to L214.
4. Reinstall cans.
5. Peak receiver per alignment procedure in service manual.
6. Tune Noise Blanker on 23.5 MHz, rather than 24.5 MHz as called for in manual.
