Service Bulletin #5

CP300/400

WARBLE ON SSB

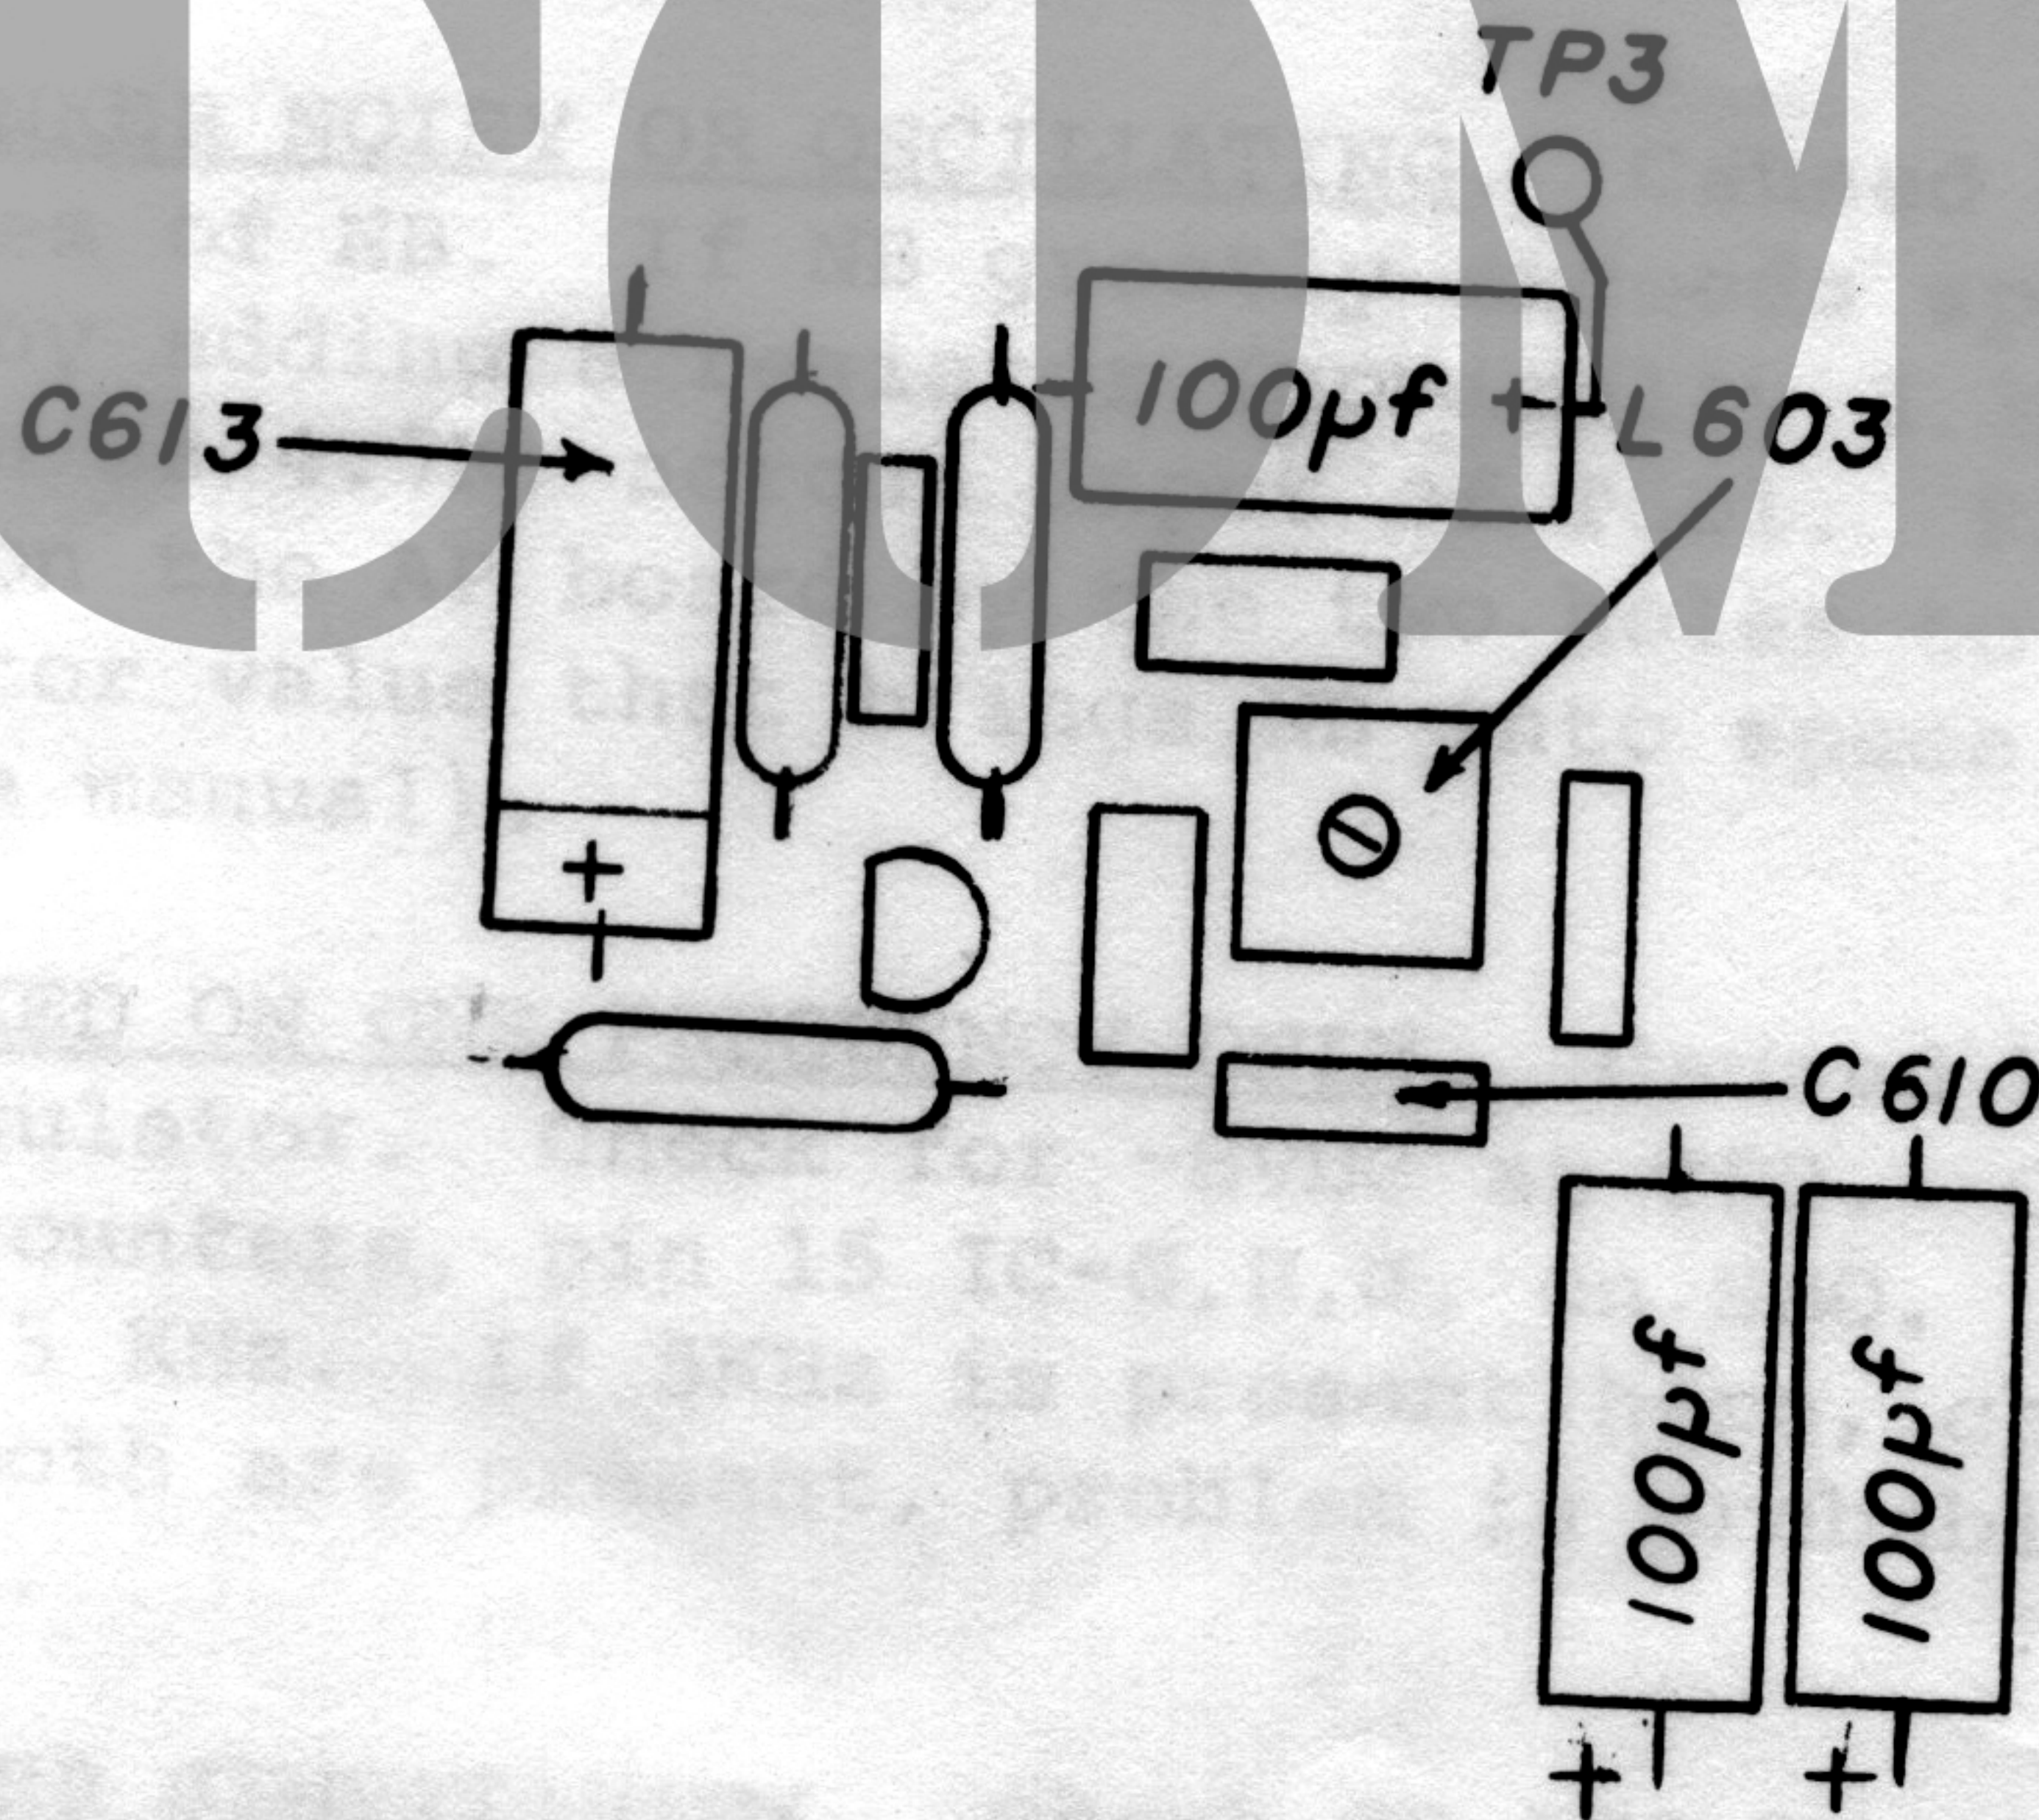
SMO BOARD
7H015

A warble on SSB, often described as "talking under water" or FM'ing on transmit can generally be cured by a simple capacitor change. The following procedure describes this modification. This change is incorporated on current production radios.

1. Change C610 on SMO (7H015) board from a .01 disc to a 68 pf disc capacitor. This capacitor is located directly in front of the VCO coil (L603). See drawing.
2. Change C613 from 10 μ f to 220 μ f. This electrolytic cap is located to the left of L603. See drawing.
3. Reset VCO coil (L603). With channel knobs on 0 0, set L603 for 2.5 VDC at TP 3.
